## Test Report

No. SZXEC2100094903

The following sample(s) was/were submitted and identified on behalf of the clients as : SOT23

SGS Job No. : RP21-000654 - SZ  
 Model No. : SOT23  
 Client Ref. Info. : SOT23、SOT363、SOT323  
 Date of Sample Received : 12 Jan 2021  
 Testing Period : 12 Jan 2021 - 18 Jan 2021  
 Test Requested : Selected test(s) as requested by client.  
 Test Method : Please refer to next page(s).  
 Test Results : Please refer to next page(s).

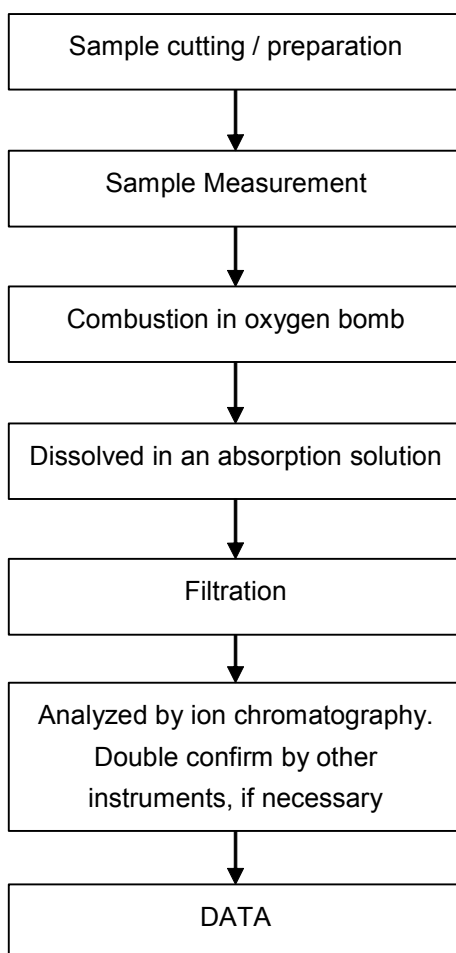
### Halogen Testing Flow Chart

Test Method : With reference to EN 14582:2016, analysis was performed by IC.
